Mold and Mildew Resistance of Nyloboard Composites Compared to that of Standard Building Products

A study conducted by Nyloboard, LLC.

June, 26 2009

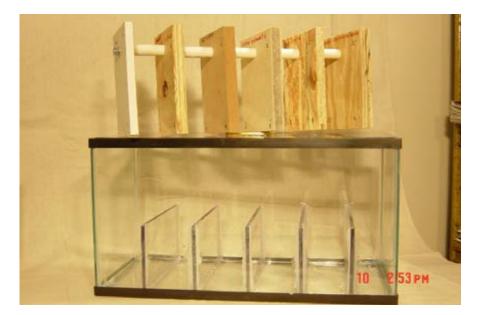
Figure 1: Test samples (L-R) gypsum board, CDX plywood, MDF, Nyloboard, OSB, Pressure treated plywood

In the study, Nyloboard was tested side-by-side with the five industry-standard construction products mentioned above. The products were placed on edge in a clear glass aquarium (Fig. 1). The test container was partially filled with standard city tap water to the same level and sealed (no chemicals were added). Each test board was separated from the others by a clear Plexiglas partition (Fig. 2), which prevented water in the aquarium from seeping between test boards. The aquarium was kept at room temperature for 30 days, during which time it was exposed to standard industrial lighting.

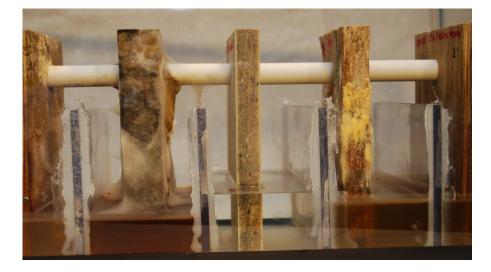
Figure 2: Test samples immersed in water. Plexiglas dividers prevent water movement between samples

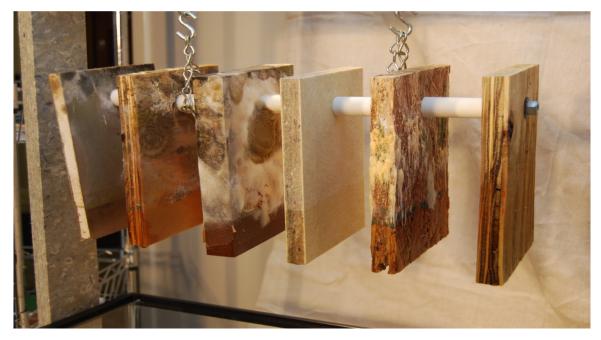
Figure 3: Test samples after 30 days in testing tank. Note mold growth on all the boards except Nyloboard (fourth from left)

After 30 days, the test boards were removed from the aquarium and examined (Fig. 3). With the exception of the Nyloboard, all five of the standard building products exhibited edge swell, substantial mold and mildew growth and water absorption. The MDF board gained the most weight and had the most extensive mold growth, 163.1 percent and 100 percent, respectively. Nyloboard had virtually no weight gain and zero mold growth, 1.3 percent and zero percent, respectively. The results of the test are summarized in Table 1.
